Re: State Project: R-2530B

Subject: Preliminary Site Assessment

Parcel #051 – Gary J & Nancy L Deeck (Deeck Mechanical, Inc.)

METALLIC UST INVESTIGATION: PARCEL 051 NCDOT PROJECT R-2530B

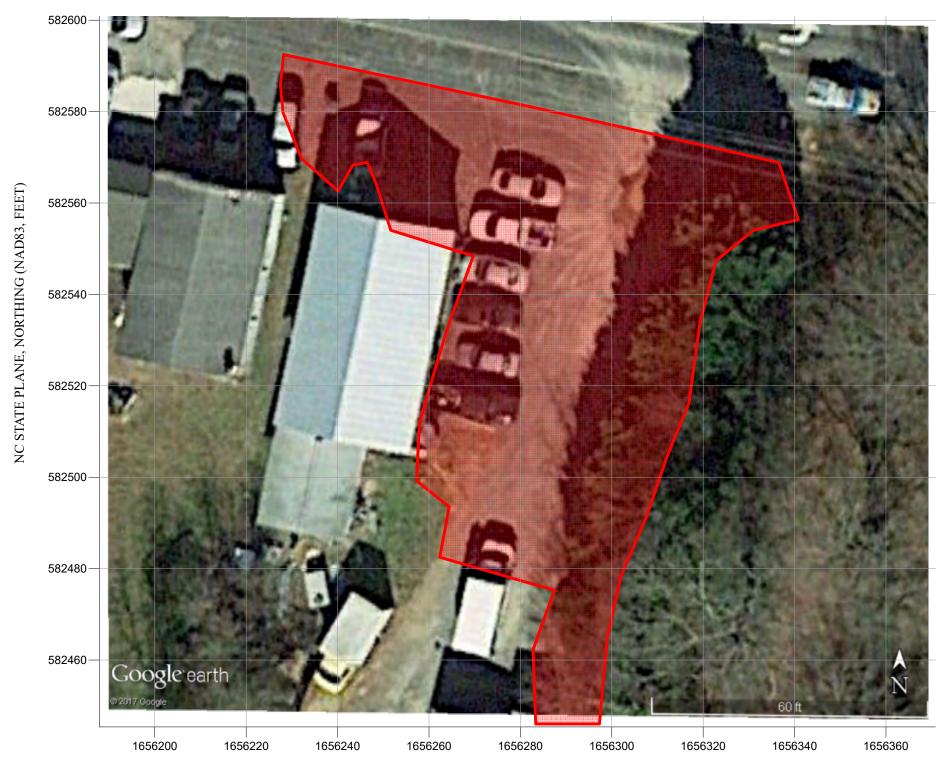
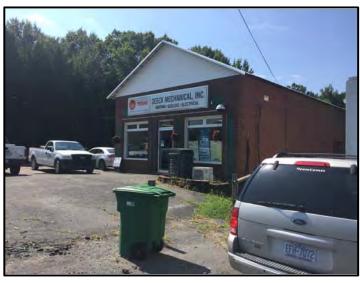
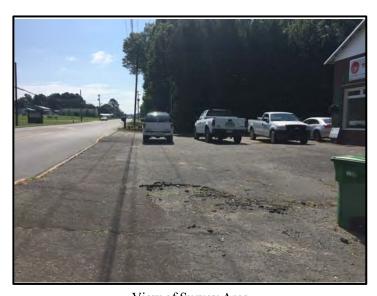
PARCEL 051 - GEOPHYSICAL SURVEY BOUNDARIES AND SITE PHOTOGRAPHS

The site included a commercial building surrounded by an asphalt parking area and grass medians. An aerial photograph showing the survey area boundaries and ground-level photographs are shown in **Figure 1**.

View of Survey Area (Facing Approximately Southeast)

View of Survey Area (Facing Approximately East)

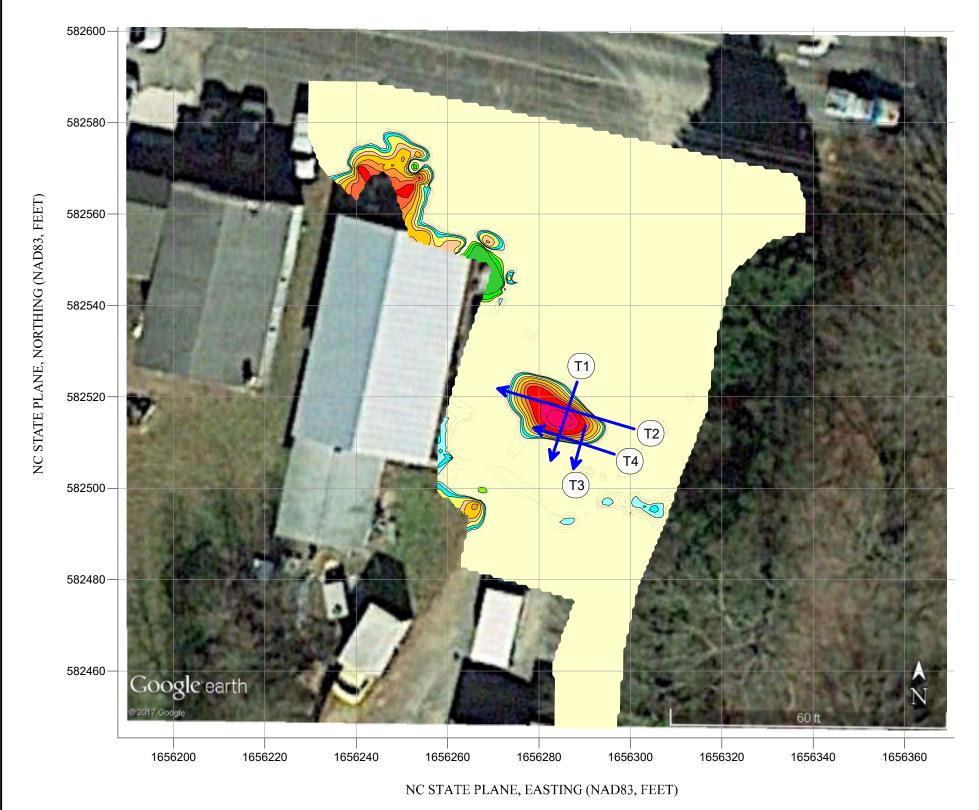
PARCEL 051 -GPR TRANSECT LOCATIONS AND IMAGES

Figure 3 presents the locations of the formal GPR transects performed at the property, as well as the transect images. A total of four GPR transects were performed at the site. The four transects showed two isolated hyperbolic reflectors and two discreet lateral reflectors that are characteristic of metal USTs. Transects 1 and 2 recorded relatively clear and consistent reflectors, while Transects 3 and 4 recorded somewhat disrupted and downwarped reflectors. For these reasons, the combined EM and GPR data resulted in this feature being classified as one probable and one possible UST. The probable UST was approximately 18 feet long and 7 feet wide at a depth of approximately 3 feet below the ground surface (center point 1656290.83, 582516.19 North Carolina State Plane NAD83, feet). The possible UST was approximately 10 feet long and 5 feet wide at a depth of approximately 2 feet below the ground surface (center point 1656289.38, 582509.60 North Carolina State Plane NAD83, feet).

- One EM feature was associated with unknown buried metal, and was investigated further by GPR.
- GPR provided evidence of two isolated hyperbolic reflectors and two discreet lateral reflectors that are characteristic of USTs. The combined geophysical data resulted in this feature being classified as one probable and one possible metallic UST.

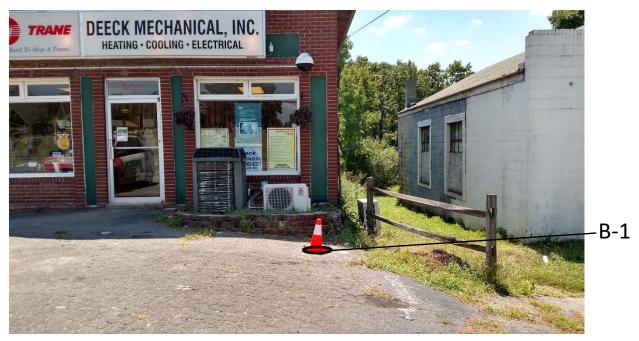
Photo #1: Boring location B-1, facing south.

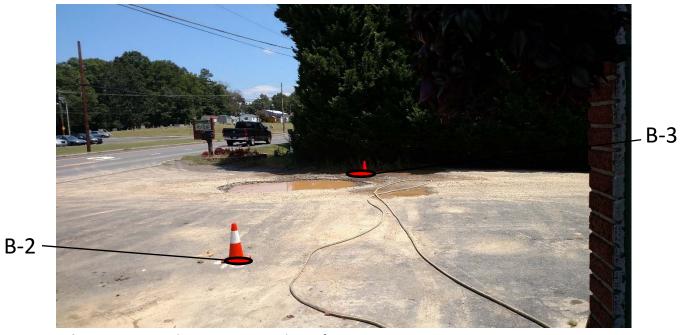
Photo #2: Boring locations B-2 and B-3, facing east.
